Analysis of the reasons of double suction centrifugal pump's failure

WITOLD LORENZ
MARCIN JANCZAK*

The issue of a pump operation beyond its recommended range and required flow conditions to the suction flange and consequently failure of double suction axially split centrifugal pump was explained. The increased vibration level, improper configuration of the suction pipeline and used hydraulics were presented. It was also illustrated how to diagnose and solve a problem which after implementation at the target workplace has confirmed the correctness of implemented design solutions.
KEYWORDS: centrifugal pump, double suction axially split centrifugal pump, pump's vibration, caviation, CFD simulations

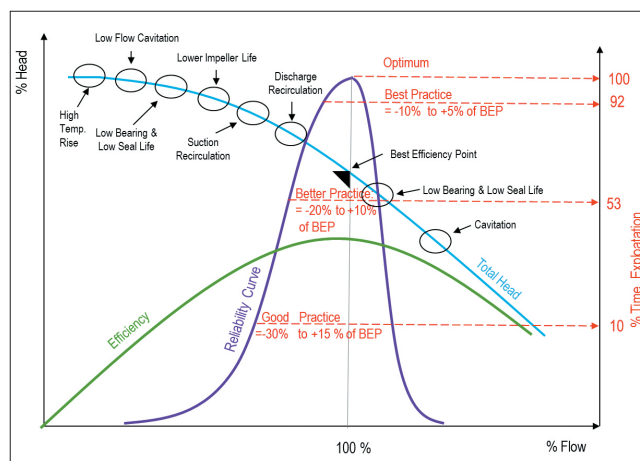
Centrifugal pumps are selected for specific parameters, however they actually work in the scope of operation; the larger scope, the larger changing demand for discharged factor. Scope of operation, reliability and timeliness of correct exploitation of centrifugal as presented in fig. 1 [5, 6]. The best scope of pump operation in the system is range $(0.9 \div 1.05) Q_{BEP}$, less recommended $(0.8 \div 0.1) Q_{BEP}$ and the least recommended but still good is a range $(0.7 \div 1.15) Q_{BEP}$.

Fig. 1. Pump curve sensitivity for pump reliability [5, 6]

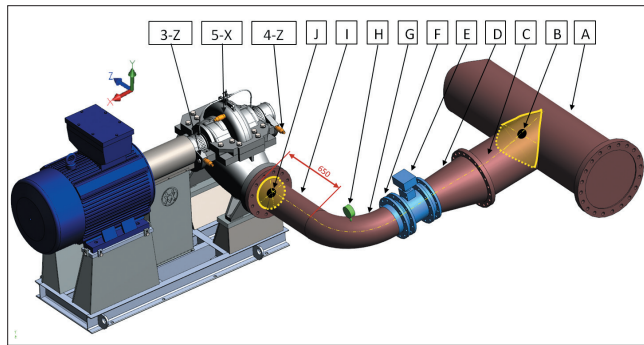
Fig. 2. Considered suction pipeline with double suction pumping unit: A – the main supply line DN500; B – contractual starting point of suction pipeline; C – pipeline DN400; D – asymmetric orifice DN400/DN250; E – butterfly valve DN250; F – compensator DN250; G – side bend 3D; DN250; H – compound vacuum gauge; I – calming section DN250; J – contractual ending point of suction pipeline; 3-Z – vibrations measurement, bearing 3; 4-Z – vibrations measurement, bearing 4; 5-X – vibrations measurement, spiral

The main power supply DN500 (A) delivered cold drinking water to the right angle suction pipeline of a pump. Pumped medium flowed through a straight section DN400 (C), asymmetric orifice DN400/DN250 (D), butterfly valve DN250 (E), rubber compensator DN250 (F), side bend „3D“, DN250 (G) and straight pipe with length $L = 650 \text{ mm}$ and flows to the pump inlet (J – cross section marked in yellow).

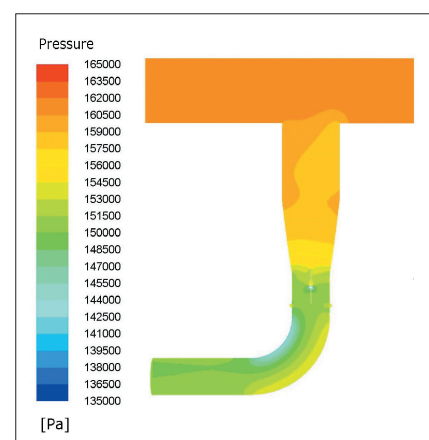
As a result of numerical tests, static pressure maps were obtained in the longitudinal section of the suction pipe line (fig. 3) and pressure drop in control section was determined (B÷J). The loss of pressure height was $h_{los} = 1.2 \text{ m}$ (fig. 3), so after taking into account and considering the pressure measured on the compound vacuum gauge (H), before the pump inlet (J), gauge pressure was accordingly $p_{p1} \approx +0.1 \div 0.3 \text{ bar}$ for $h_{p1} = 1.9 \text{ m}$ and $p_{p2} \approx +0.5 \text{ bar}$ for $h_{p2} = 4.5 \text{ m}$. Obtained results, apparently excluded the possibility of operation in the first stage of cavitation as confirmed at fig. 3.

Fig. 3. Static pressure profile in the control section of the suction pipe line

Due to the above, there was a suspicion of high pressure drop on the control section, i.e. from the outlet of the main power supply (B, fig. 1) to the pump inlet (J). However, observations of the compound vacuum gauge mounted on the suction pipe line (H), for both values of water level, indicated the gauge pressure correspondingly $p_{m1} \approx +0.2 \div 0.4 \text{ bar}$ and $p_{m2} \approx +0.6 \text{ bar}$. The installed pump was characterized by required anti cavitation surplus $NPSHR_{pp} = 5 \text{ m}$ which means that it should work correctly at gauge pressure up to $p_m \approx -0.4 \text{ bar}$. In order to find the cause of the sudden pressure drop the compound vacuum gauge and to illustrate the flow numerical analysis CFD were carried out. Digitized according to the mathematical modelling 3D geometry of the system was implemented in the commercial computational code ANSYS Fluent and simulations of flow in steady-state simulations were carried out [3].

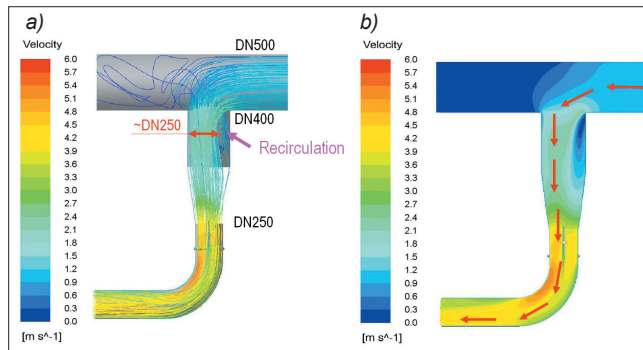
The next stage of research was to check the flow quality in the considered section (B÷J). The liquid particle trajectories are shown at fig. 4a. The liquid from the main supply

Fig. 4. Suction pipe line, tracks of liquid particles (a), speed map in control cross section (b)

line DN500 flowed to DN400 in this way that the active part of the cross section in which liquid flowed was reduced to dimension corresponding to pipeline type-size ~DN250. This was due to recirculation, which narrowed the active cross section. As a consequence, the liquid in the pipeline flowed at a higher velocity than it appears from the pipe-line cross section, and after flowing through side bend (G), caused considerable unevenness of the velocity field in control cross section ($B=J$, fig. 4b) and in pump's suction flange (J, yellow colour – fig. 1). The numerically obtained speed profile for flow in steady state was presented at fig. 4b. Due to the fact that the flow accompanying physical phenomenon was variable over time, another numerical simulation of flow in unspecified state was carried out. It was simulated $t = 4.1$ s of flow and the result is shown in the form of 4 speed maps, read in cross section (J). The results have shown that the speed change profile depends on time. Analysing the obtained velocity profile of the liquid flowing into the suction flange of the pump, significant increase in speed was noticed ($v_{IR} \approx 4.4$ m/s) in the right part of the pump inlet (R, fig. 5a) and decreasing speed in the left part (L) of inlet ($v_{IL} \approx 3.5$ m/s). In addition, the structure of the profile varied over time, causing its instability illustrated at fig. 5b.

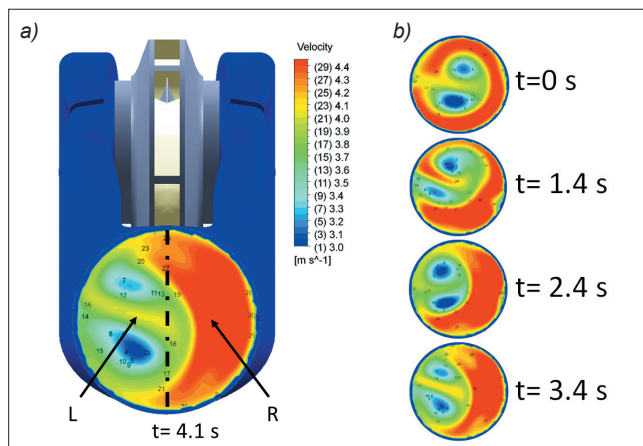
Fig. 5. Pump inlet with speed profile after $t = 4.1$ s (a) and intermediate steps during the analysis (b)

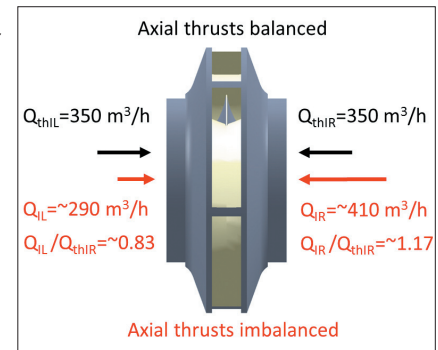
In double suction pump the liquid after flowing through the inlet section splits into 2 streams which are brought to mirror set inlets of double stream impeller. For capacity $Q_{pp} = 700$ m³/h, each impeller inlet should be fed with $Q_{thIL,R} \approx 350$ m³/h. Such solution would ensure the balance of axial forces (fig. 6).

Whereas, in the case of the analysed problem, on the basis of obtained speed profile it was assumed that the first part of pump inlet (R) is supplied with flow $Q_{IR} \approx 410$ m³/h ($Q_{IR}/Q_{thIR} \approx 1.17$), while second part

Fig. 6. Flow to the double stream impeller

– $Q_{IL} \approx 290$ m³/h ($Q_{IL}/Q_{thIL} \approx 0.83$). Such strong, variable speed field at the inlet to the pump caused the creation of excessive and variable (over time as to the value and operation direction) of the axial forces which were damaging bearings. Referring to estimated capacities of individual impeller's inlets and comparing them with pump reliability chart, it is noticed that half of the impeller fed with capacity ($Q_{IL}/Q_{thIL} \approx 0.83$), operates in the field of increased vibration caused by recirculation of the liquid at the pump outlet, shortening optimal operating time to ~58% in comparison to its computational life time (fig. 7). The second part of impeller worked with excessive capacity ($Q_{IR}/Q_{thIR} \approx 1.17$) in the area of increased wearing of bearings and seals and close to the first phase of cavitation, as indicated by previous vibration measurements. Cavitation, associated with increased flow velocity, affected on increased vibrations, which further reduced the life time of bearings up to ~2% (fig. 7).

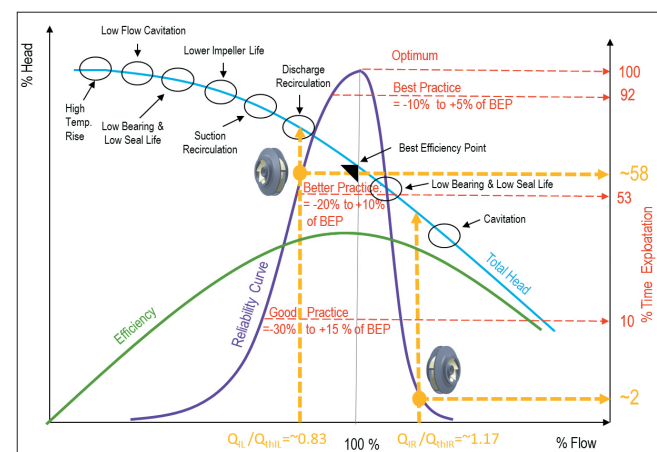
Fig. 7. A summary of the operation of both pump's impeller inlets with a pump reliability chart

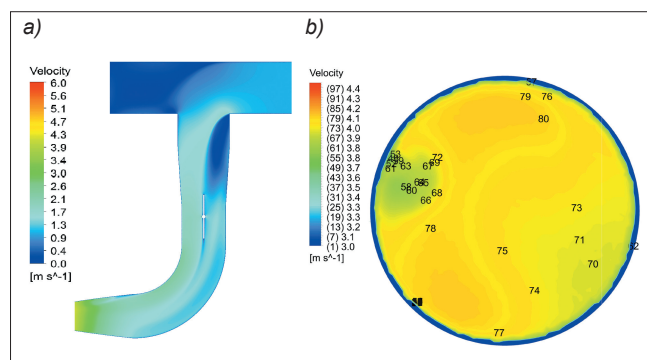
On the basis of carried out simulations and analyses, taking into account local installation conditions, the pipeline on the suction side has been rebuilt. Considered test section together with elbow was made in size DN400, and only before the pump inlet an asymmetric reducer was applied. The visualization of speed maps in this section obtained by numerical calculations is illustrated at fig. 8a and 8b. The speed profile in the inlet section of the pump has been aligned, and difference between minimal and maximal speed was only $\Delta v_1 \approx 0.3$ m/s. Due to the fact that there was no possibility of rebuilding the main supply line connection (A) with considered section of the suction pipeline, the recirculation zone in area (B) was not eliminated. However, overriding and possible for implementation aim in the presented layout was to align the speed profile at the pump inlet (fig. 8a and 8b) this was achieved by lowering the speed in the elbow and fittings and the

Fig. 8. Speed maps in cross-section (a) and in pump inlet cross-section (b)

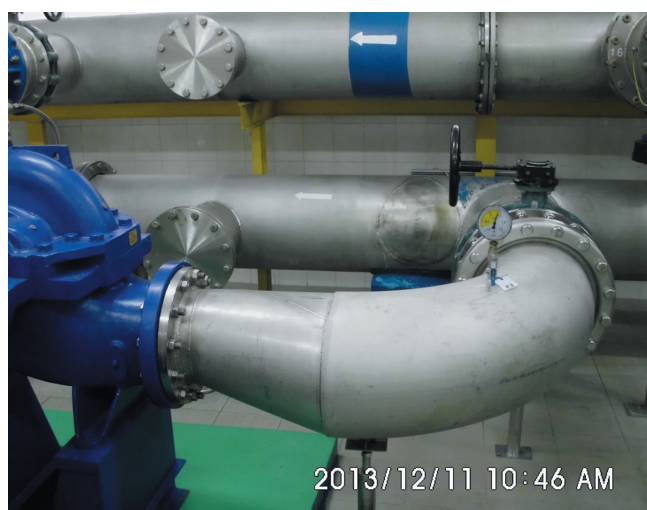
Fig. 9. Implementation of proposed suction line design

liquid was accelerated only before the pump inlet. Confirmation of the rightness of conducted research was its verification on the target working station of the pump. The implementation of the proposed design solution is shown at fig. 9 and it completely eliminated the problem.
